Landslide, Mud and Debris Flow

Lucas Valley has experienced shallow, rainfall-triggered landslides emanating from just below the summit of Big Rock Ridge which have produced damaging mud and debris flows.

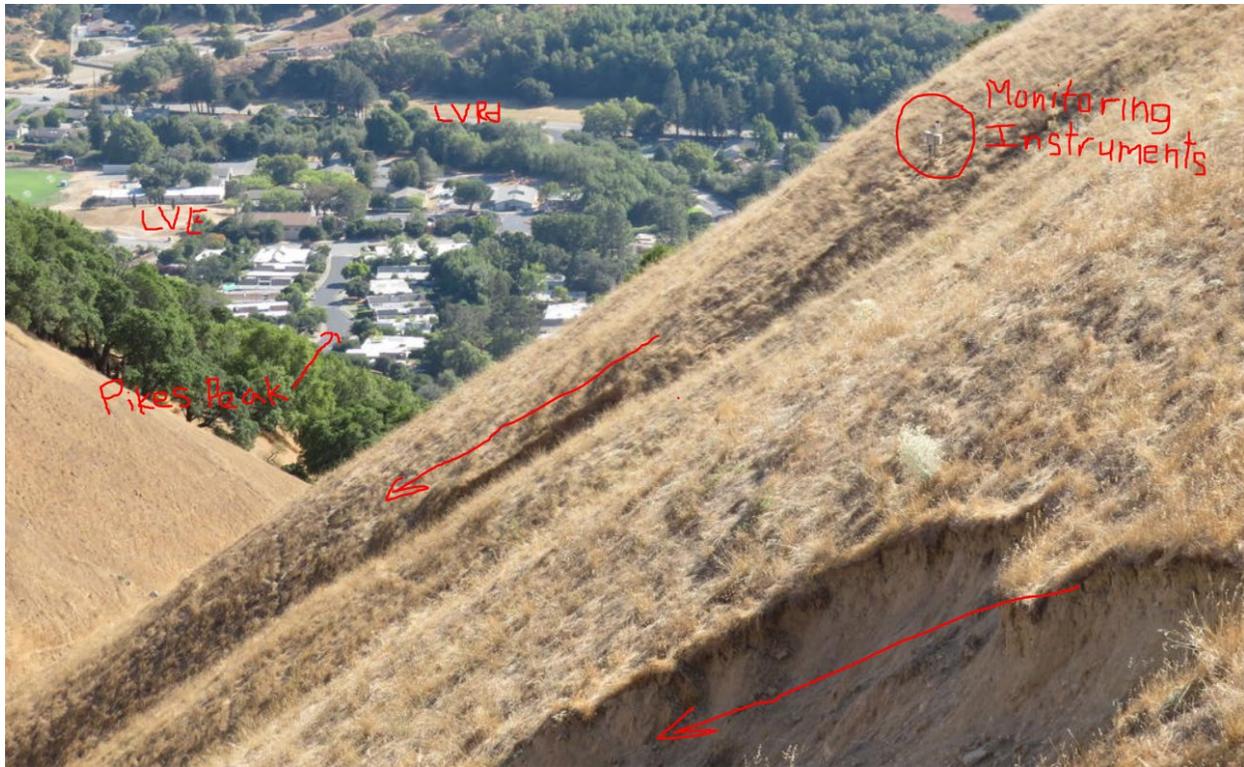
The USGS “BALT2” site located in Marin County consists of dataloggers monitoring the hillslope in the central part of the image. This slope is typical for many in the Marin County region that have generated mobile debris flows in the past. Evidence of two recent landslides are shown in the fore- and middle-ground. The area consists of grasslands over an approximately 1-meter-deep sandy soil layer, underlain by sandstone.

Following the Jan. 2006 event, USGS installed monitoring instruments on Big Rock Ridge, its second monitoring site in the Bay Area. Data from this installation became available online in Nov. 2019 at [San Francisco Bay Area – Marin County \(BALT2\) Site near San Rafael, CA](#)

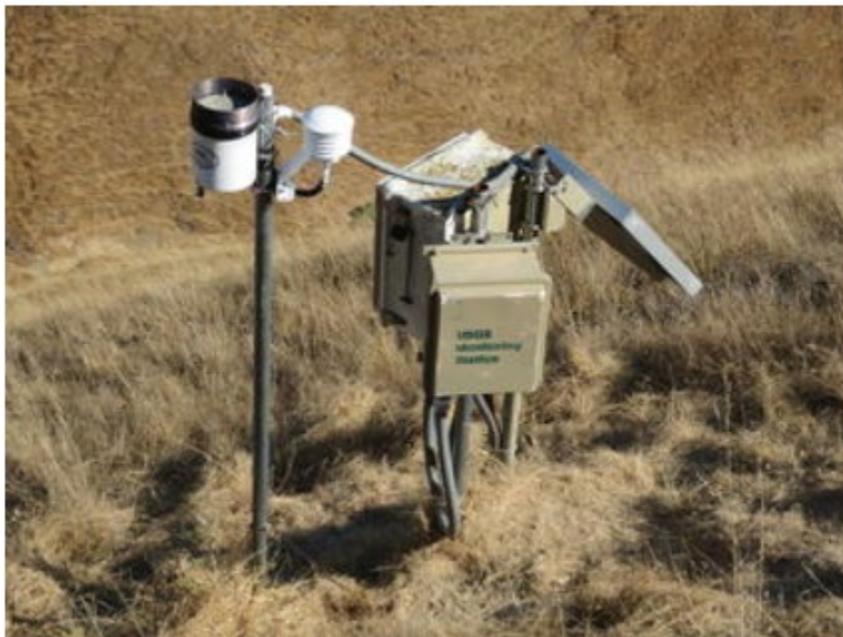
The USGS “BALT2” monitoring site showing datalogger enclosures, solar panel (far right), air temperature and relative humidity sensor (left, white), and rainfall gauge (far left, brown and white).
